Solution for the Problem of Loud Knocking Sound in LPH 3 at 2 x 250 MW Paras TPS, MSEB, Maharashtra

Naveen Prakash* and S. K. Baveja
Department of Heat Exchange Engineering,
BHEL, Haridwar, Uttarakhand, 249403.
*naveen@bhelhwr.co.in

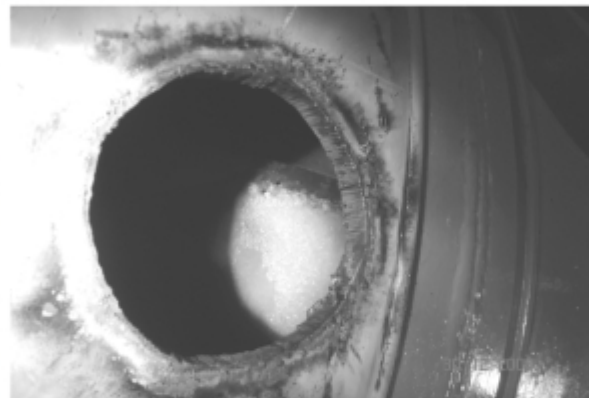
- a) It was decided to cut the vent pipe on one side of the shell and and gas-cut a hole on the other side of the shell. After gas-cutting, attempt was made to see the defect.

Figure 2: Holes cut on the either side of the LP Heater shell to see the welding between Drain cooling Zone shroud / Partition Plate / Sealing Ring

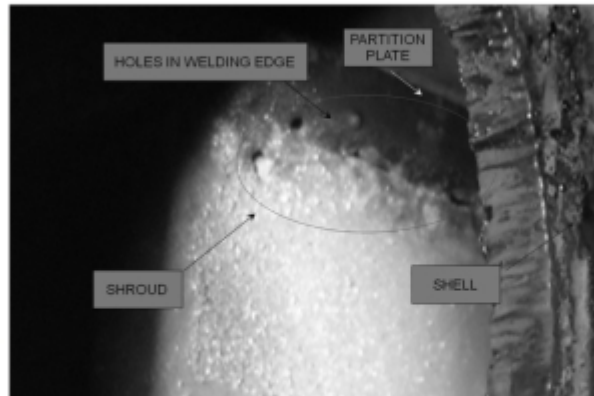
ii) / iii) Since , there was no knocking sound coming from inside the heater when condensate level was increased up to the centerline of the heater, hence, there was strong possibility that there might be some defect along the weld edge between shroud and the partition plate. This weld edge / line is about 1200 mm in length. Hence, it was decided to see this weld edge with-out cutting the shell.

Figure 3: Weld edge between shroud and Partition Plate is having holes from where live-steam was leaking into Drain Cooling zone enclosed with-in shroud.

- a) Heater was taken out of service, the extraction valve was fully throttled and heater was isolated from extraction steam by cutting the connection between steam nozzle and steam extraction line.
- b) Heater was cut from shell cutting line and shell was taken out by the distance so that complete edge of shroud and partition plate welding was seen.
- c) Welding defects were corrected as below
- d) Heater was re-assembled and cut holes were blanked.
- e) On operation, Heater was found to be working satisfactorily.

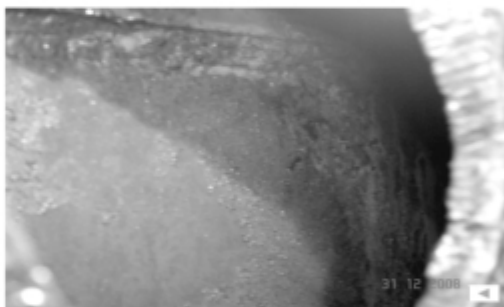
Figure 5: Photograph taken after the welding, showing no weld gaps/holes.

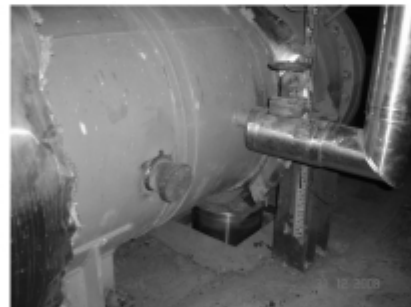
Figure 6: Holes made on the LPH shell were blanked.
